CONDITIONS ASSESSMENT

FIRST PARISH UNITARIAN CHURCH & MEETINGHOUSE

ORANGE RD WARWICK, MA

OCTOBER, 2025

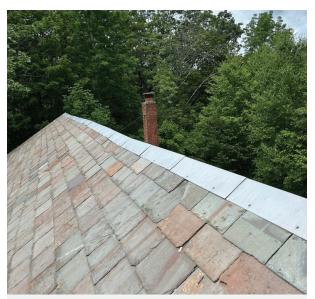
While there does not appear to be evidence of leaking, the present slate roof is near the end of its life expectancy. Unfortunately, it is typical of slate to outlive the lifespan of the ferrous nails that fasten them. At the Unitarian Church there are numerous broken and missing individual slates. [Image A-02]

Image A-02: Photo 2 slate detail shows weathered and missing slates and copper ridge cap

Unfortunately, despite there being limited evidence of active leaks, all of the roofs and flashings observed above are near the end of their life expectancy. They should be replaced, and the choice of material for replacement opens a preservation-based debate. Research of documentation seems to identify the original roof as wood shingled, and that would be consistent with expectations of the era and style. It seems to have lasted until 1896, when the decision was made to replace it with slate. The slate choice was a good one as it has delivered well over 125 years of service.

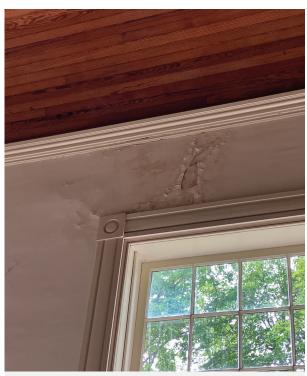
At the building interior, plaster and paint damage is some locations indicate that leaks have occurred. [Image A-07] It is difficult to determine whether these are currently active leaks, but there are a couple of locations where cornice/eave deterioration is observed from the exterior [Image A-08], and daylight is visible from the attic interior [Image A-09]

Image A-07: Detail of interior plaster and paint damage indicates leak location

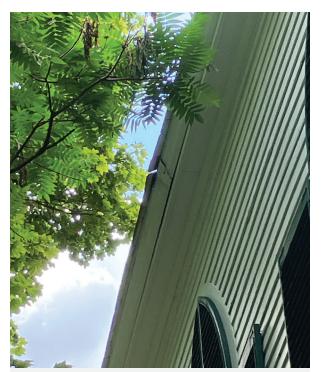
Image A-08: Suspected leak location at deteriorated cornice

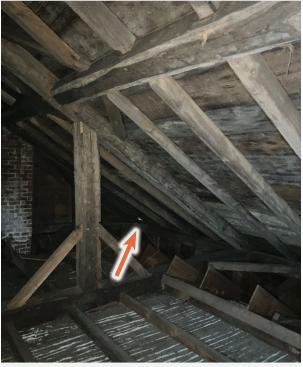
Image A-09: Daylight is observed in attic interior, indicated with arrow

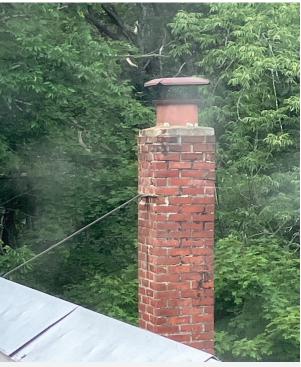
There are two brick chimneys at the west end of the sanctuary. The chimney on the south side has been dismantled from the top down to the roof line where the roof has been infilled. The chimney of the north side remains as originally built. Its mortar joints are deteriorated and the top cap appears to be a brick cap that was parged with a cementitious coating. The chimney is currently active as a flue to the existing oil-fired furnace. [Image A-13]

Image A-13: View of existing chimney on the north roof plane

Mortar joints at the existing brick chimney should be cut and pointed. The parge coat at the cap should be inspected and may require mortar repair.

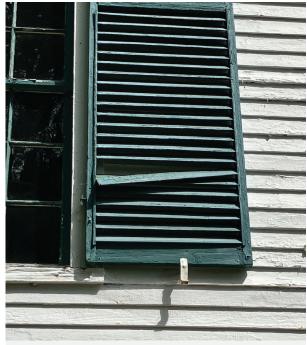
The shutters are in fair condition, with most of their wooden louver blades existing, albeit many are loose. [Images A-25, 26]

Image A-25: Existing shutters are mostly in goof condition, with some loose blades

- Restore existing shutters, re-securing all loose wood louver blades. Scrape, sand, prime and paint using appropriate lead-containing paint management procedures.

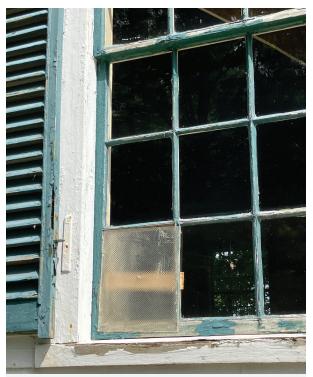
Image A-29: Existing windows have glazing putty failure but are generally structurally sound

- Remove sashes from window openings and install temporary plywood sheathing to protect the interior. Transport sashes to shop for repair.
- Repair deteriorated window sashes (off site, in shop) using two-part epoxy system / replace stiles and rails damaged beyond repair.
- Replace cracked or broken window panes with new to match the original glass.
- Replace damaged/deteriorated muntins with new to match existing.
- Remove all cracked and deteriorated window putty and re-glaze.
- Scrape, sand, and paint restored window sashes.
- Reinstall sash.
- Provide and install historically appropriate, operable, exterior storm windows at all windows. Storm windows will protect the newly restored primary windows, extending their life, and providing thermal and infiltration improvement to the windows

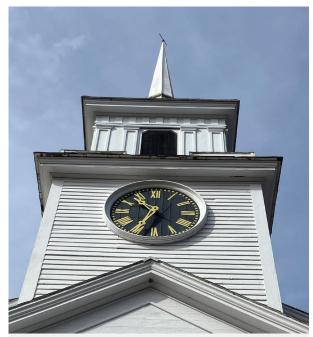
The 2008 restoration of the clockface when the new gold numerals and ticks were installed has held up well and no work appears necessary at this time. [Image A-31]

Image A-31: The existing clock faces restored in 2008 remain in goof condition

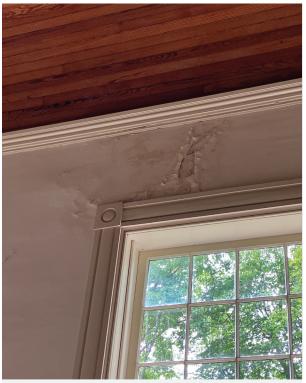
Image B-07: Interior plaster disruption betraying water damage and roof leakage

Very little is required for repairs to the interior of the existing meeting hall space. There is some minor deterioration of plaster caused by roof leaks that should be patched and painted, but the plaster is stable for the most part. [Image B-07]

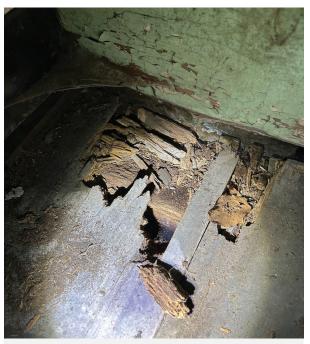
Image B-11: Deteriorated floor

As Structures North has stated in their assessment report, some more investigation requiring removal of flooring is required for a full inspection of the floor framing condition. From what is visible in areas of missing floor boards, it is very likely that moisture from the poorly ventilated crawl space has contributed to deterioration and perhaps insect damage to existing floor joists. [Image **B-11**] The weakened floor, coupled with the poor egress to the basement reinforces the current policy that the Town has which prevents occupancy. More information is needed on the floor condition. The crawl space condition could be improved by introducing a moisture barrier to reduce ground moisture to the structure.

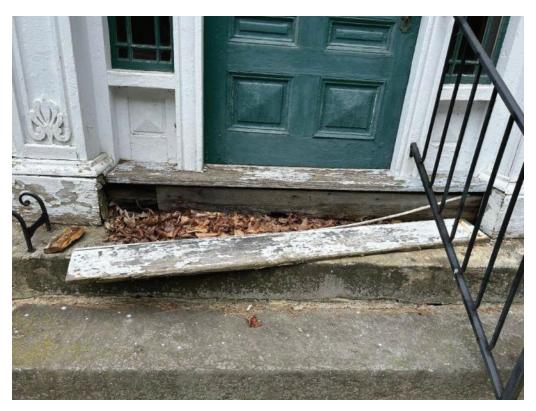
Photo 2Eroded mortar joints, damaged trim, and rotted sill plate

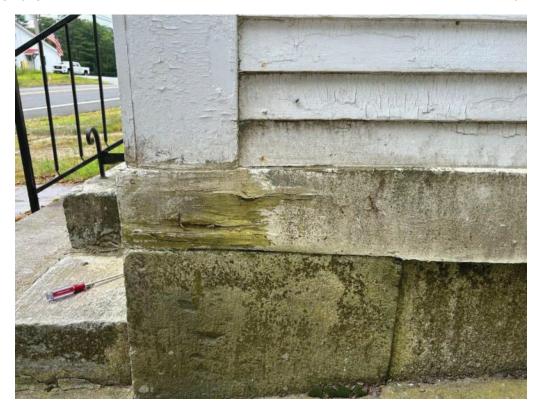
Photo 3
Crushing and rotted sill plate

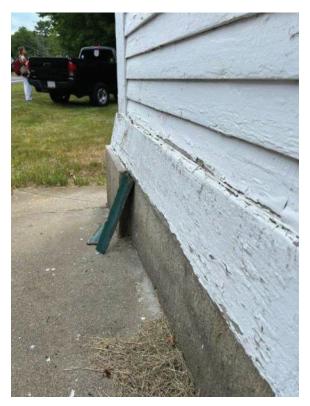
Photo 4
Rotated sill and shifted foundation stone

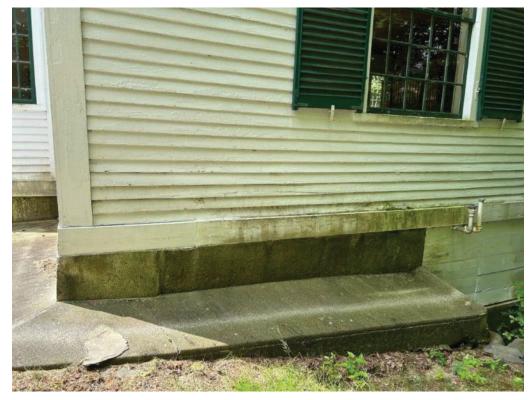
Photo 5
Cracked concrete slab on grade at north elevation and bowing foundation

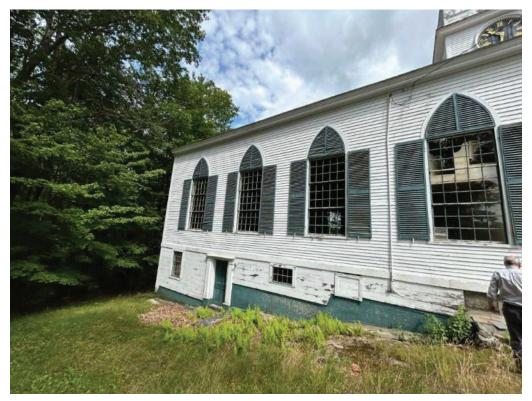
Photo 6
Peeling paint at south elevation

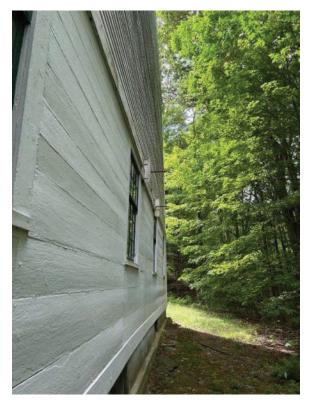
Photo 7
Outward bowing west elevation with past wall reinforcement rods

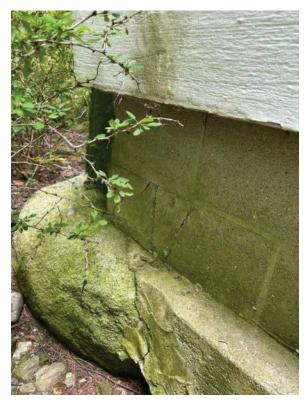
Photo 8
Step cracks at northwest corner of foundation

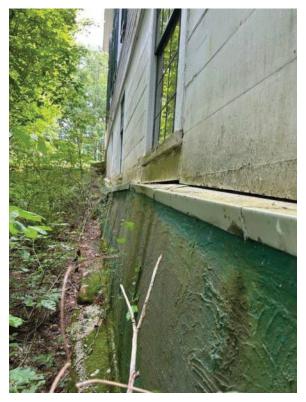
Photo 9
Sloped flashing over top of concrete foundation

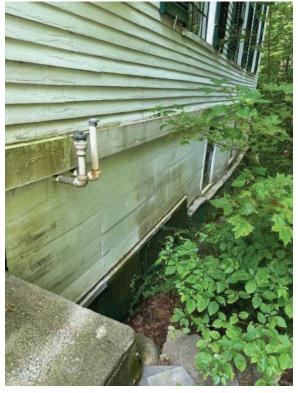
Photo 10
Algae and brush covered north elevation

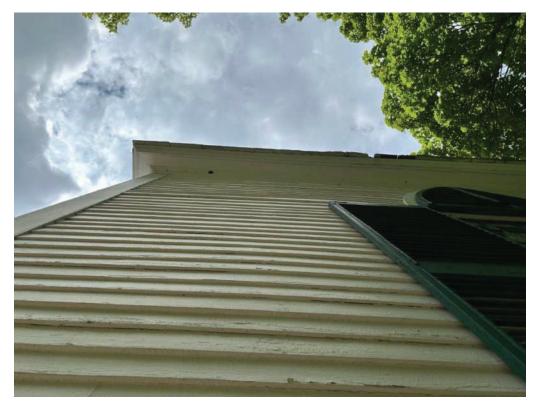
Photo 11
Hole in soffit board

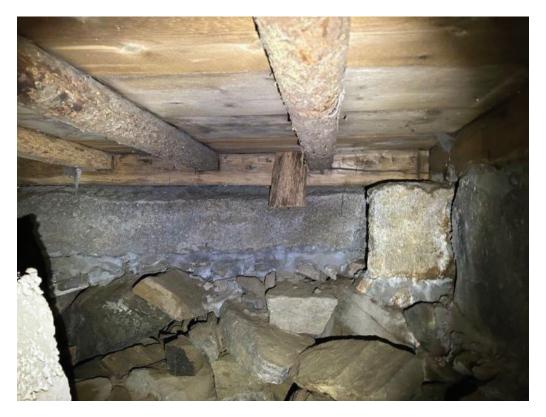
Photo 12
Uneven bearing surface for sill plate contributing to rotation

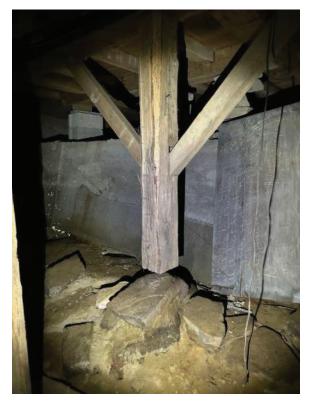
Photo 13 Unsupported post end

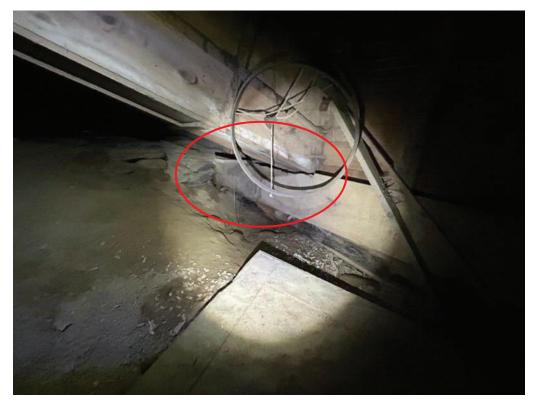
Photo 14
Partially rotted beam in soil below wall

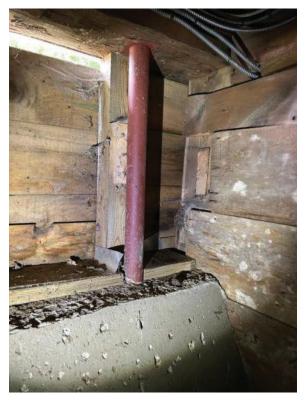
Photo 15
Lally column with poor cap plate and rusting base

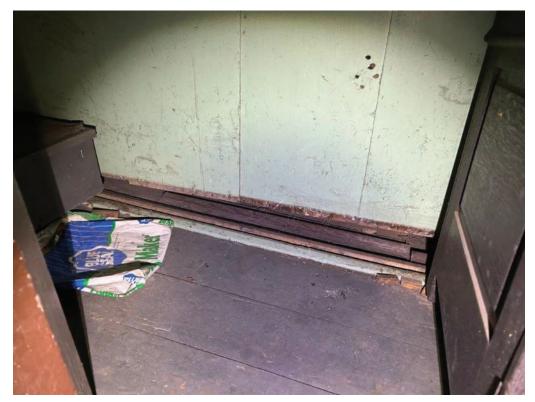
Photo 16Drop in basement floor

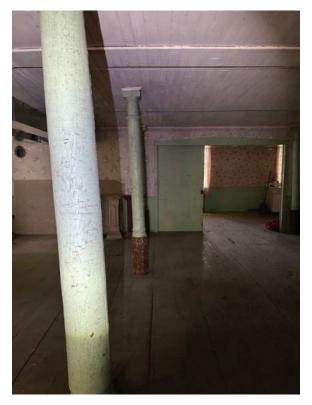
Photo 17
Tilt in basement column from undulation in basement floor

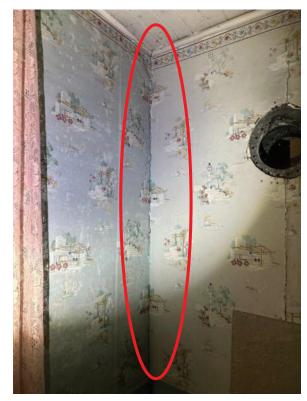
Photo 18
Crack revealing outward movement of west wall

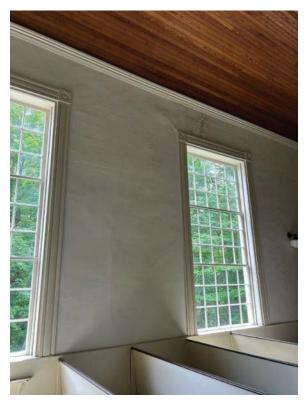
Photo 19
Past water damage over window

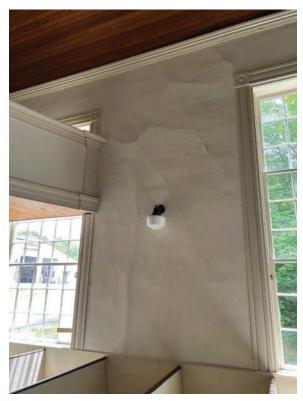
Photo 20
Diagonal shear cracks at end of balcony

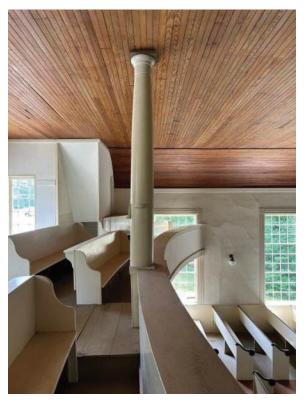
Photo 21
Tilted column support at balcony

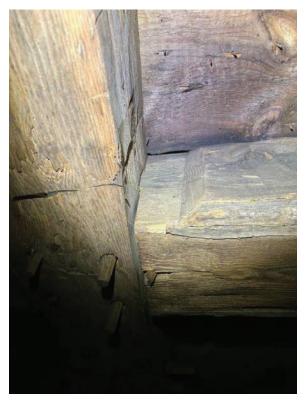
Photo 22
Typical notch at roof purlin

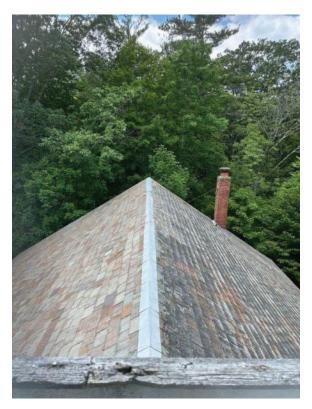
Photo 23 Chimney above roof line

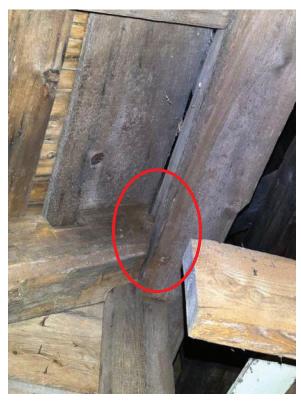
Photo 24
Roof rafter pulling out from mortise

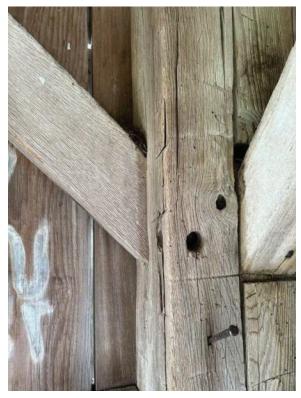
Photo 25
Missing peg from connection
